# **Five-Year Review Report**

**Commencement Bay  
South Tacoma Channel Superfund Sites  
Tacoma, Washington**

**Third Five-Year Review Report for  
Well 12A (OU 1/2/3)**

**September 2008**

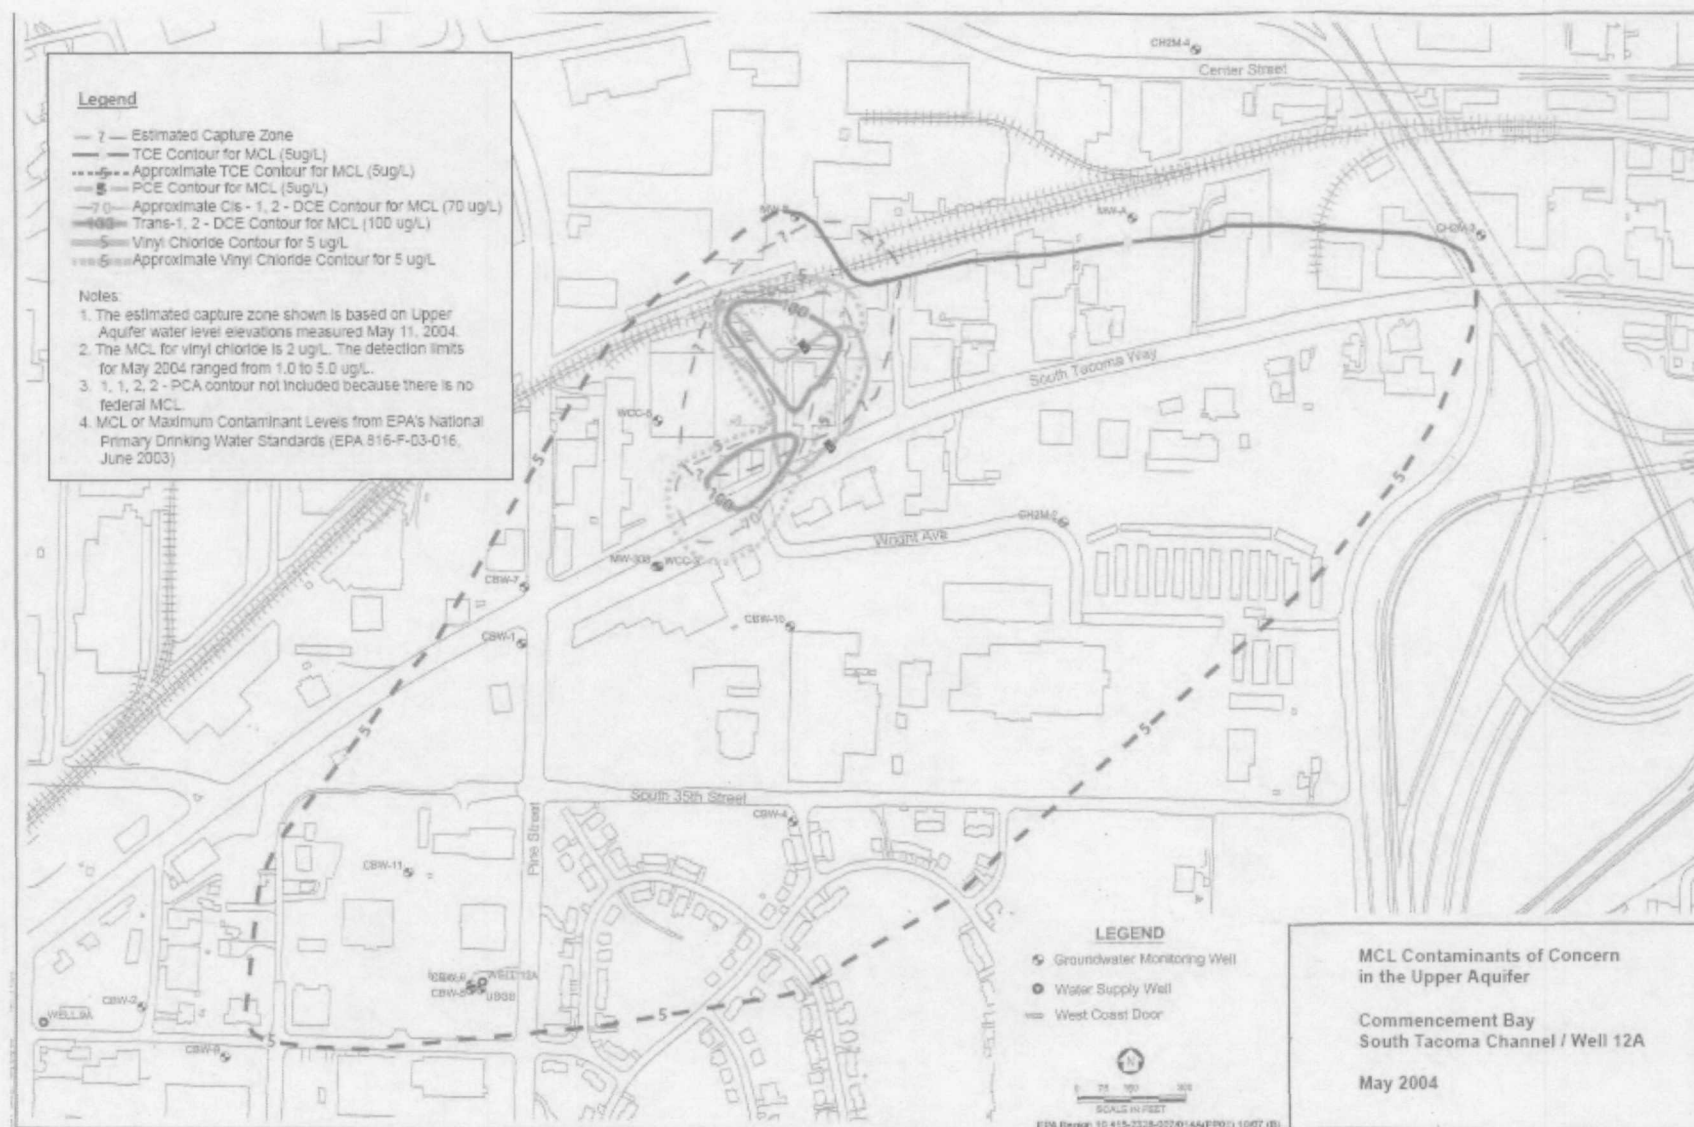
Figure 1-4. Well 12A Lateral Extent of Groundwater Plumes and Estimated Capture Zone

TCE concentrations above the MCL are not currently being captured by the GETS system (Figure 1-4). Concentrations of 1,4-dioxane in ICF-2 and MW-308 also indicate its presence beyond the capture zone. The remaining COC concentrations above MCLs are largely contained within the capture zone of the extraction wells. Since capture of the TCE plume above MCL was deemed impracticable, the CZA report recommended that the target capture zone be expanded to encompass the 500 µg/L TCE contour. The analysis concluded that more than one additional extraction well would be required to accomplish this.

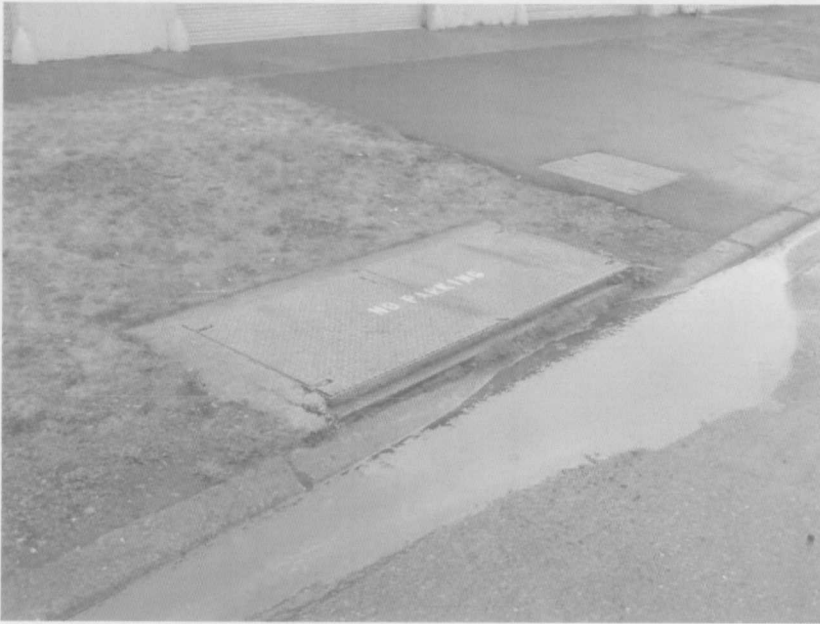
The GETS system and associated extraction wells were observed to be in working condition during the site inspection. The five extraction wells are all in below grade vaults. The electrical and plumbing systems that connect the extraction wells to the treatment system are all below grade. Fencing around the GETS and the associated office/storage trailer was intact.

Photo 1. Extraction Well 2

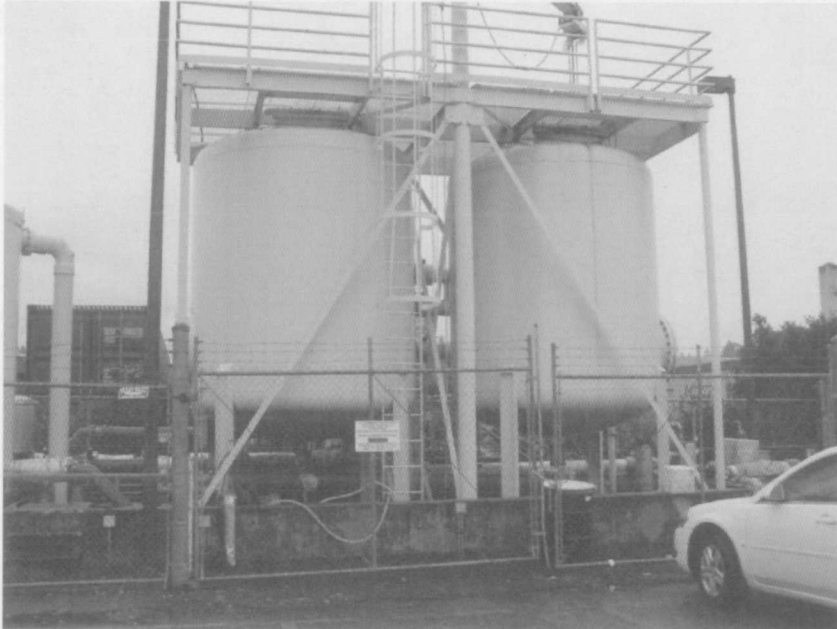
Photo 2. GETS system

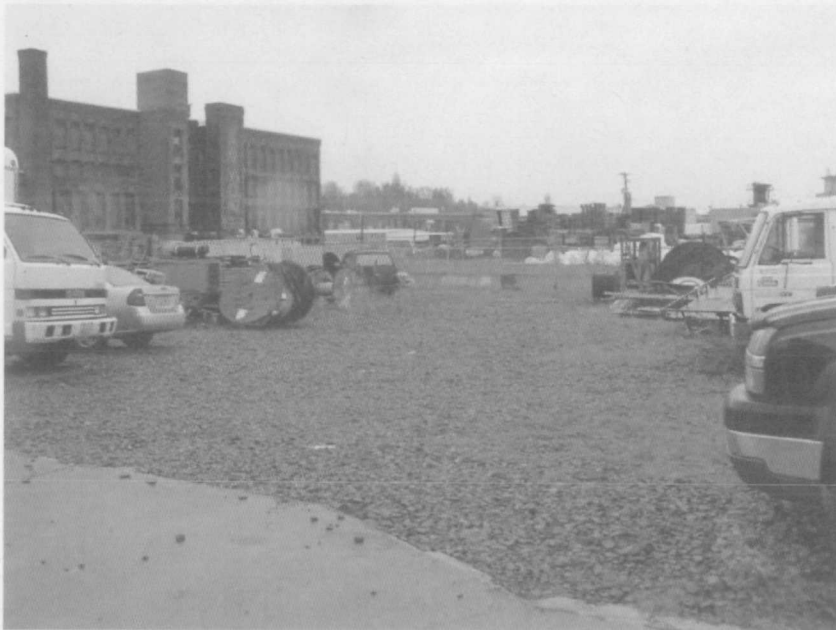
The former Time Oil property use was confirmed to be commercial and industrial. The site was completely still paved, with the exception of the former warehouse east of the East Tank Farm. This area is covered with rock. Several drums related to EPA sampling and remedial activities were observed near the VES building. According to the EPA RPM, these drums are scheduled for removal in the near future. Two site buildings are present on the site and appear to be used for office and storage space. The adjacent area is also used for commercial and industrial purposes.

Photo 3. Gravel pad east of East Tank Farm

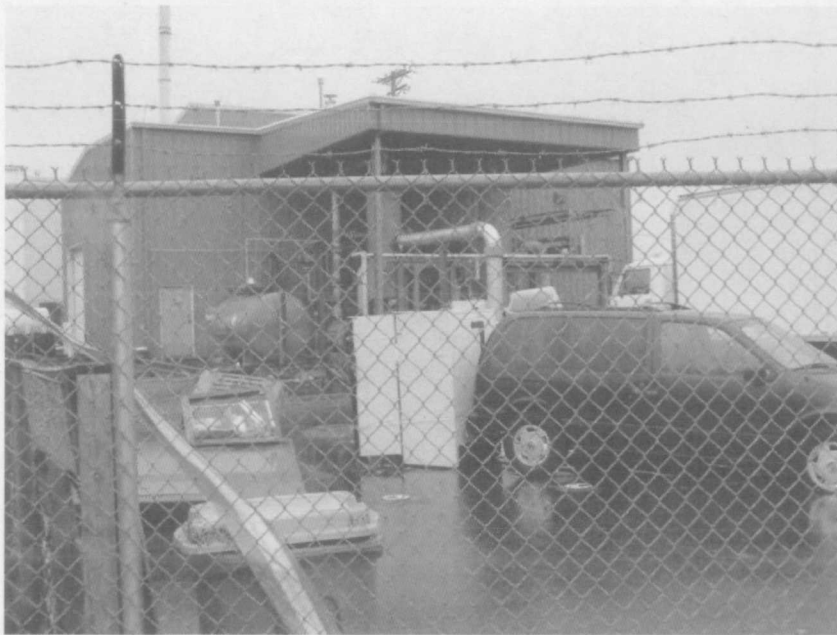
9. Drums on site that may contain hazardous waste derived from site investigations	Y	Y
10. O&M not transferred to Ecology via new SSC	N	N

Photo 4. Former VES Building (drums on left edge of photo)

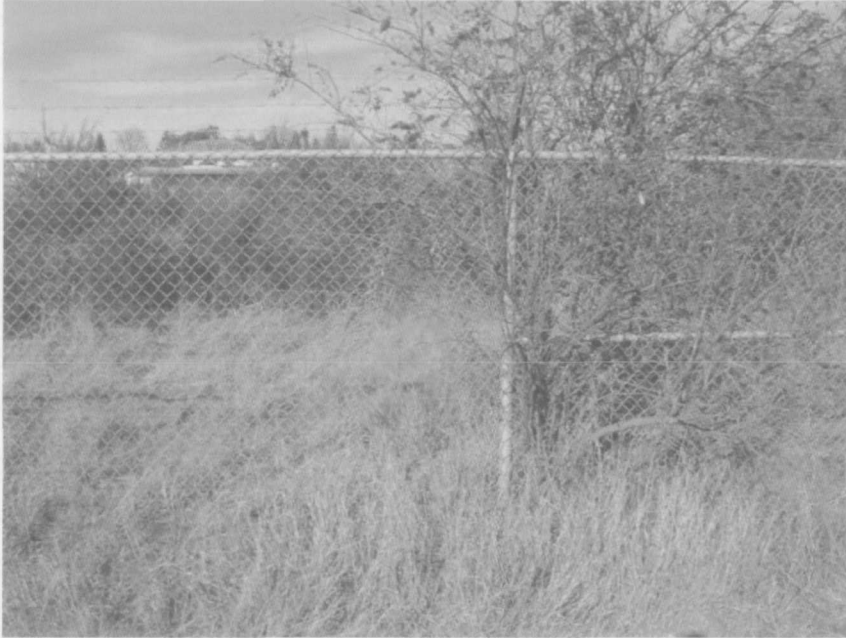
Photo 1. Hole in North Containment Area Fence

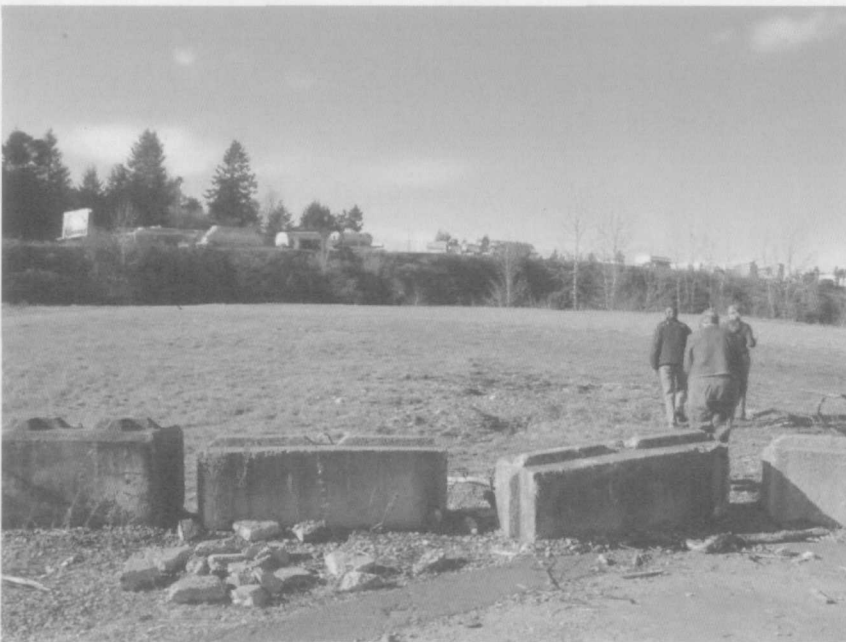
Photo 2. Cap Grid 879, jersey barriers placed to block vehicle access.

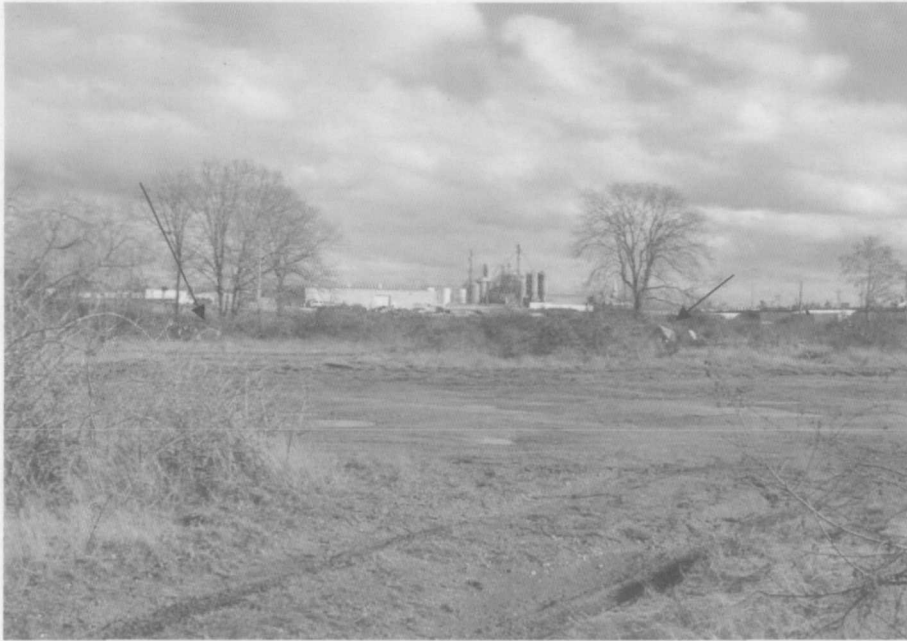
Photo 3. Two tents in southwest portion of site.

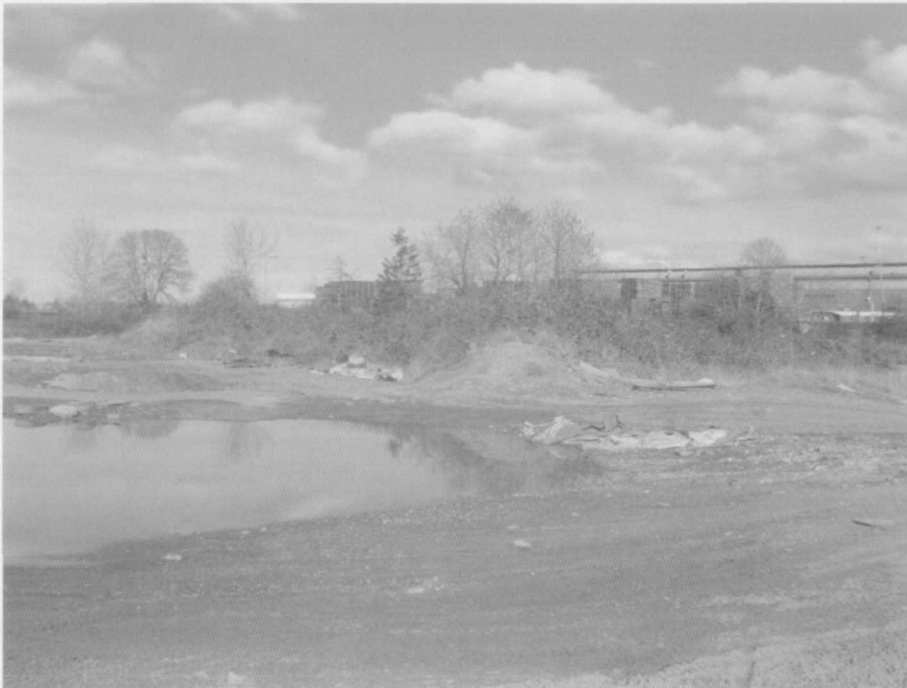
Photo 4. Southwest area of site, near grid 767 and 785.

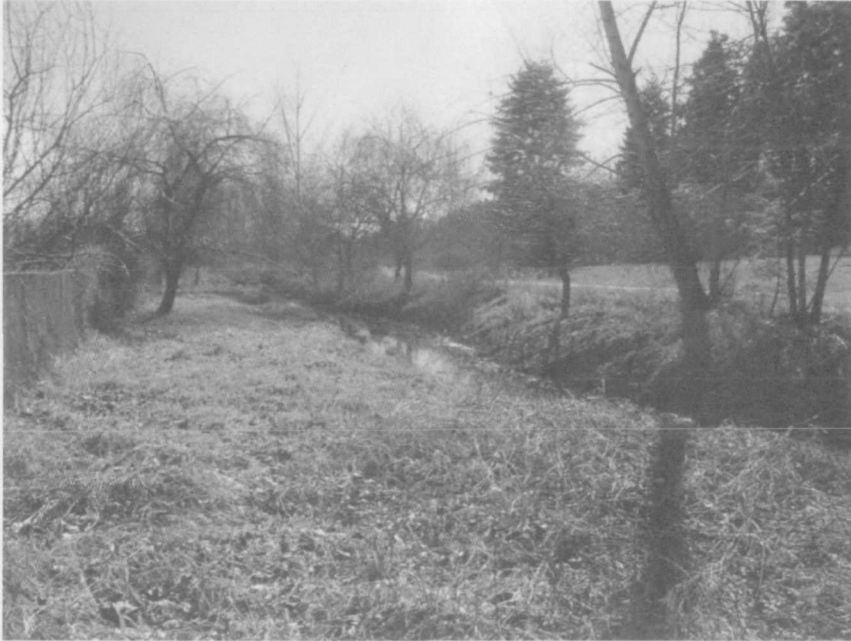
Photo 5: Storm water channel on western boundary of site.
